# CREEP CORROSION ON LEAD-FREE PRINTED CIRCUIT BOARDS IN HIGH SULFUR ENVIRONMENTS

**Randy Schueller, Ph.D.**  
**Dell Inc., Austin, Texas**  
**randy\_schueller@dell.com**

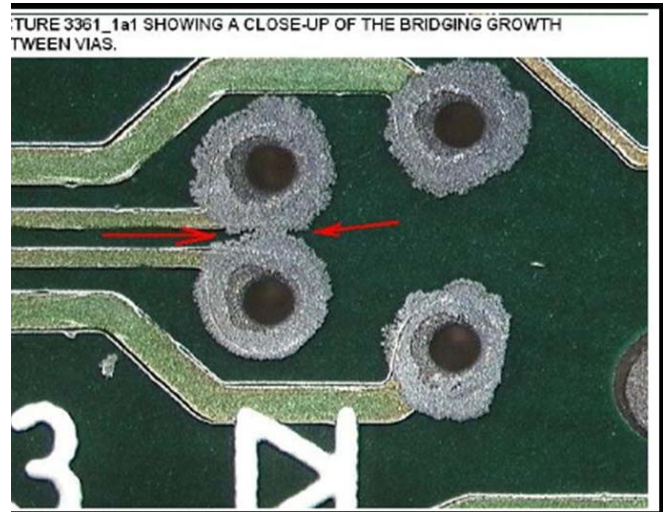
**Figure 1.** Creep corrosion field failure in high sulfur environment (bridging vias).

A typical creep corrosion failure is shown in Figure 1. Figure 2 provides an EDX spectrum of the corrosion product. It is primarily copper sulfide ( $Cu_2S$ ) with a small amount of silver sulfide ( $Ag_2S$ ). Studies have shown that high amounts of  $Cu_2S$  typically indicate the presence of active sulfur compounds such as elemental sulfur, hydrogen sulfide ( $H_2S$ ), or organic sulfur compounds [7]. Creep appears to begin by growth of dendrites, as shown on a HDD in an early stage of corrosion (Figure 3). However, this is not electro-chemical migration (voltage potential driven) dendritic growth, since creep takes place equally in

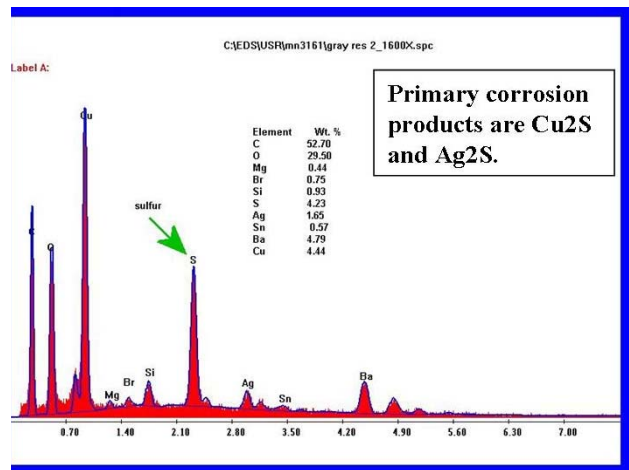
**Figure 2.** EDX of typical creep corrosion product.

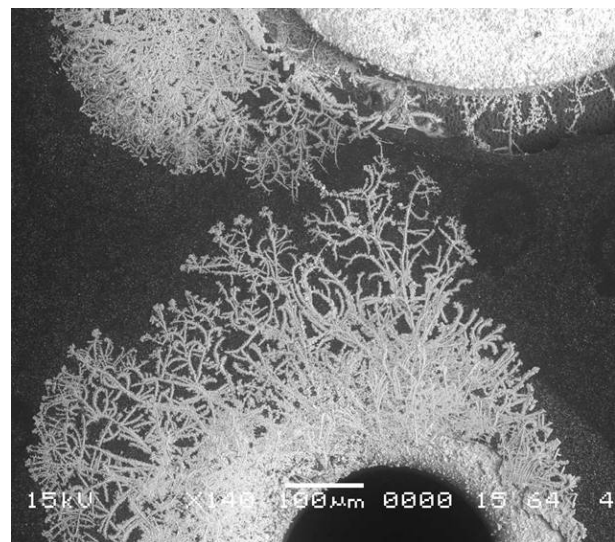
**Figure 3.** HDD with ImAg surface finish.  $Cu_2S$  precipitates out of solution in a dendritic structure.

all directions and does not require the board to be powered. Rather it appears that  $Cu_2S$  is being formed in a layer of moisture on the surface and precipitates out of solution as it forms (since  $Cu_2S$  is insoluble in water).
